Manhole Inspection Summary

Manhole # S23KK_004MH

Insp Date: **9/29/07 8:18 AM**

Location Address: **501 CUMBERLAND ST**

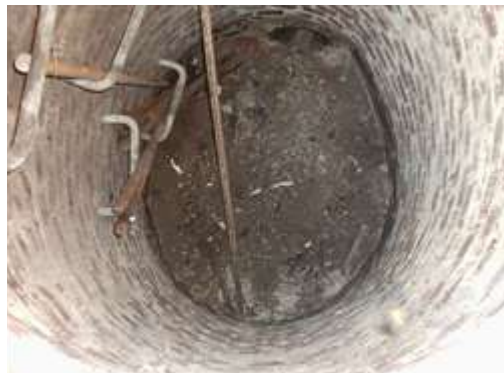
Top View

Channel debris.

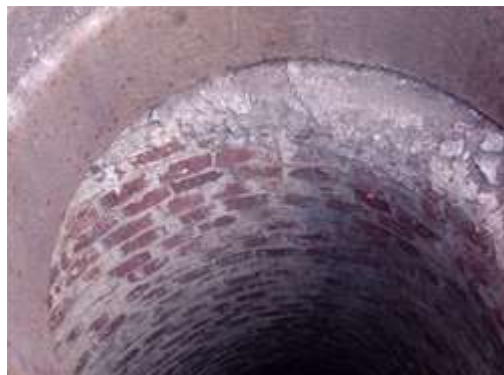
Defect

Frame leaks. Frame offset. Adjustment deterioration and infiltration - other side.

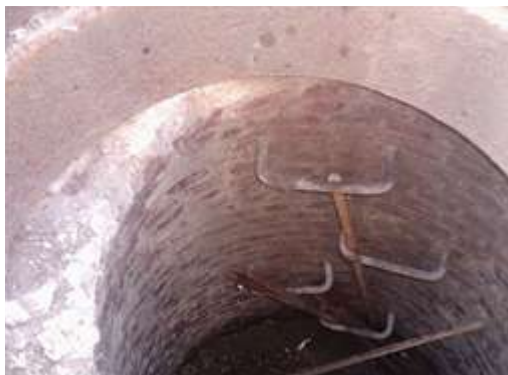
Defect

Frame leaks. Frame offset. Adjustment deterioration and infiltration.

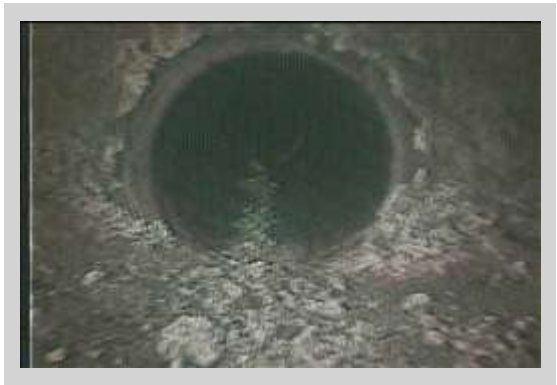
8 in. Circular Gravity Sewer
Pipe Out @ 12 O'Clock

Deposits: ☐ None ☒ **Mud** ☐ Sludge ☒ **Debris** ☐ Grease

Infiltration: **Evidence** Pipe Seal Cond: **Unknown**
